**Jurisdictional Delineation Report
Los Angeles International Airport
Proposed Runway 6L-24R and Runway 6R-24L
Safety Area and Associated Improvements Project**

**Prepared by:
SAPPHOS ENVIRONMENTAL, INC.
430 North Halstead Street
Pasadena, California 91107**

January 24, 2014

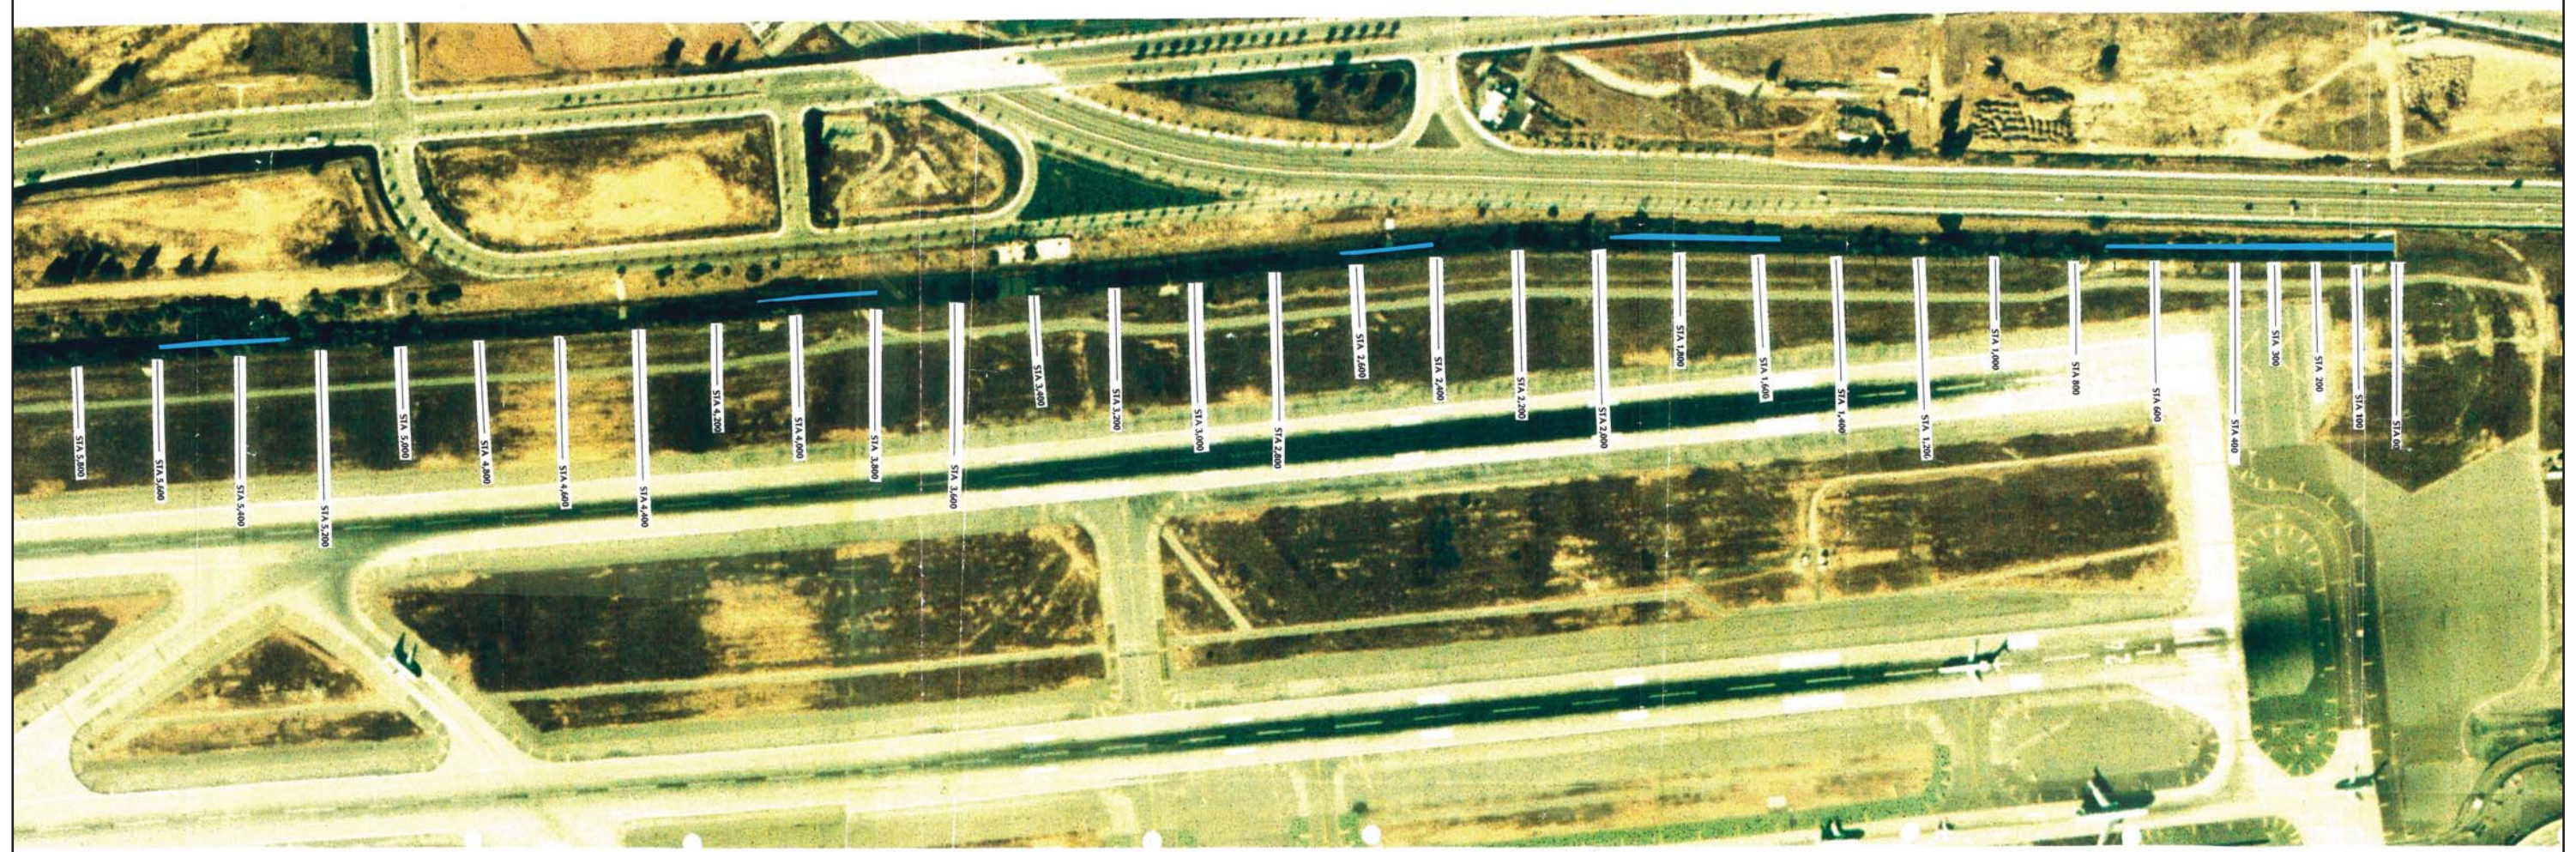
FIGURE 4.1-1
1997 Delineation of the Argo Ditch

A jurisdictional delineation of the Argo Ditch was completed in support of emergency channel maintenance activities in October 1997. Sampling occurred every 100 feet for wetland vegetation, hydrology, and soil for a total of 99 locations. During the 1997 delineation of the Argo Ditch, Sapphos Environmental, Inc. found “riparian and wetland habitat created in association with the Argo Ditch”.²⁵ Wetlands were found within the man-made ditch in limited areas (~ 1 acre in total), mostly within the eastern portions of the Argo Ditch (Figure 4.1-1, *1997 Delineation of the Argo Ditch*). Sapphos Environmental, Inc. also documented riparian vegetation dominated by willows but lacking wetlands in the mid-portions of the Argo Ditch.
